Peatland Restoration

Peatland restoration at Glensaugh is a key element of our wider regenerative catchment management and whole system approach to tackling the climate and biodiversity crises.

Peatland Restoration at Glensaugh

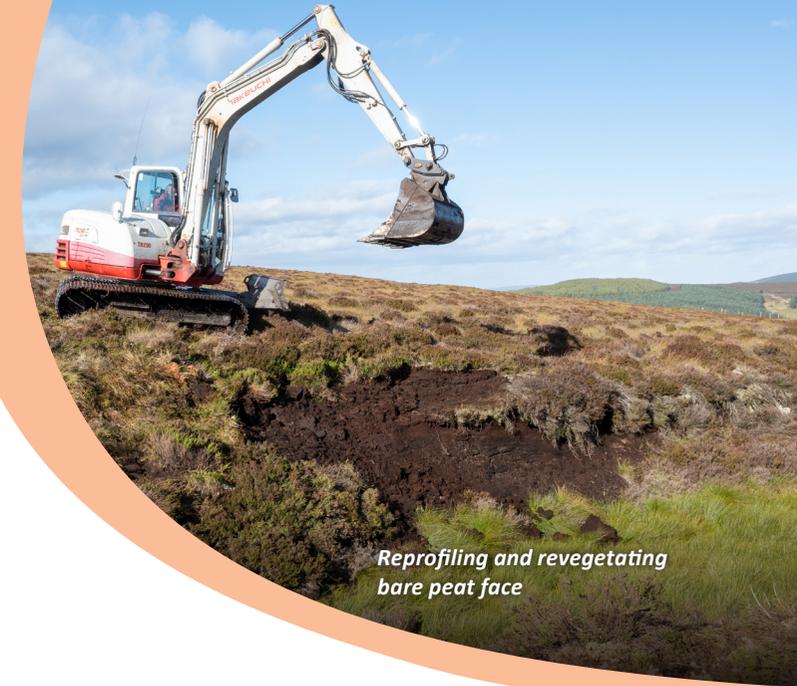
Reprofiling and revegetating bare peat face

- **Revegetating exposed peat:** bare peat faces were reprofiled to a shallower slope and then revegetated using turves from small "borrow areas" nearby. Recovery of borrow areas was facilitated by stretching existing vegetation around their edges, leaving only shallow depressions that will form valuable small pools for wildlife and mosses.

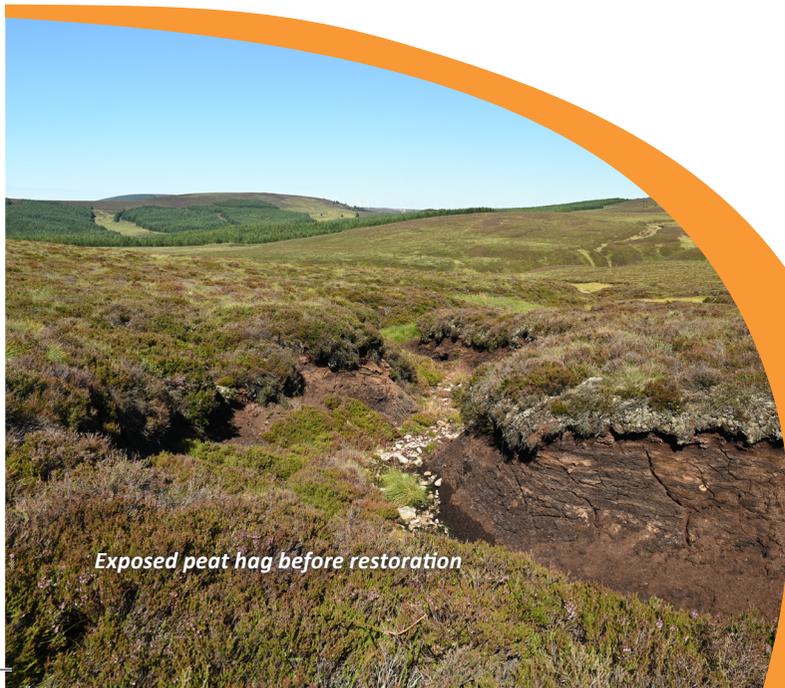
The peatland at Glensaugh is fairly typical of upland blanket bog in Scotland. Prior to restoration, it was intersected by extensive patches of bare peat hags and exposed gully sides, leading to active erosion and drainage of some of the surrounding peatland.

Exposed peat hag before restoration

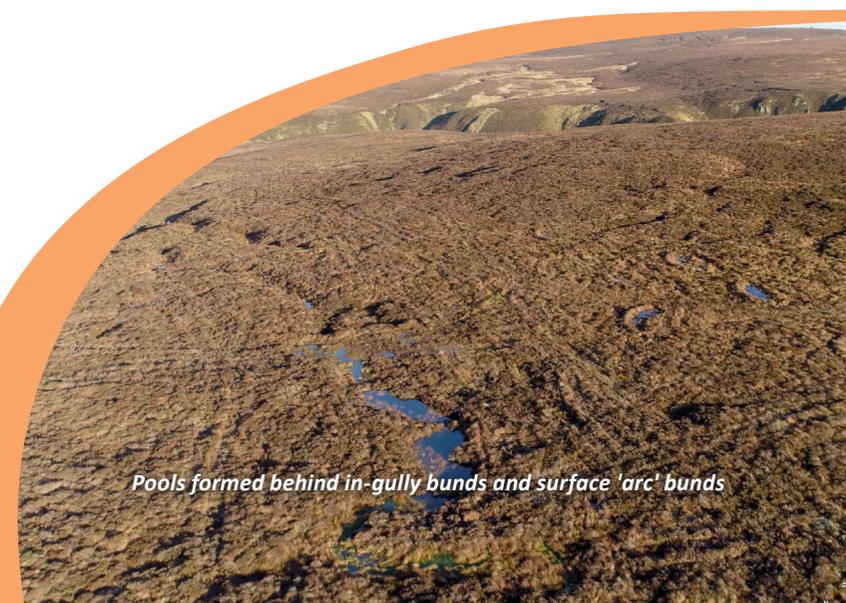
Pools formed behind in-gully bunds and surface 'arc' bunds

- **In-gully bunds and baffles:** within gullies, low peat and turf "bunds" were constructed to slow water flow, help to trap and build up sediment, and create shallow pools to encourage vegetation regrowth. In wider gullies, where there was a danger of impounding too much water, small peat deflector baffles were constructed instead to slow water flow and deflect it away from the base of the hag to reduce erosion risk.

- **Surface 'Arc' bunds:** low, crescent-shaped bunds were constructed on some slopes above eroding gully systems to help attenuate surface water flows into the gullies, holding more water in newly created bog pools and surrounding peatland, thereby supporting the transition to a healthier habitat.
